INVENTOR: Daniel BARICH, Timothy DONAHUE, Ade AUDIFFEREN
FOR: METHOD AND ARRANGEMENT FOR INSPECTION AND
REQUALIFICATION OF VEHICLES USED FOR TRANSPORTING
COMMODITIES AND/OR HAZARDOUS MATERIALS

**METHOD AND ARRANGEMENT FOR INSPECTION AND
REQUALIFICATION OF VEHICLES USED FOR TRANSPORTING
COMMODITIES AND/OR HAZARDOUS MATERIALS**

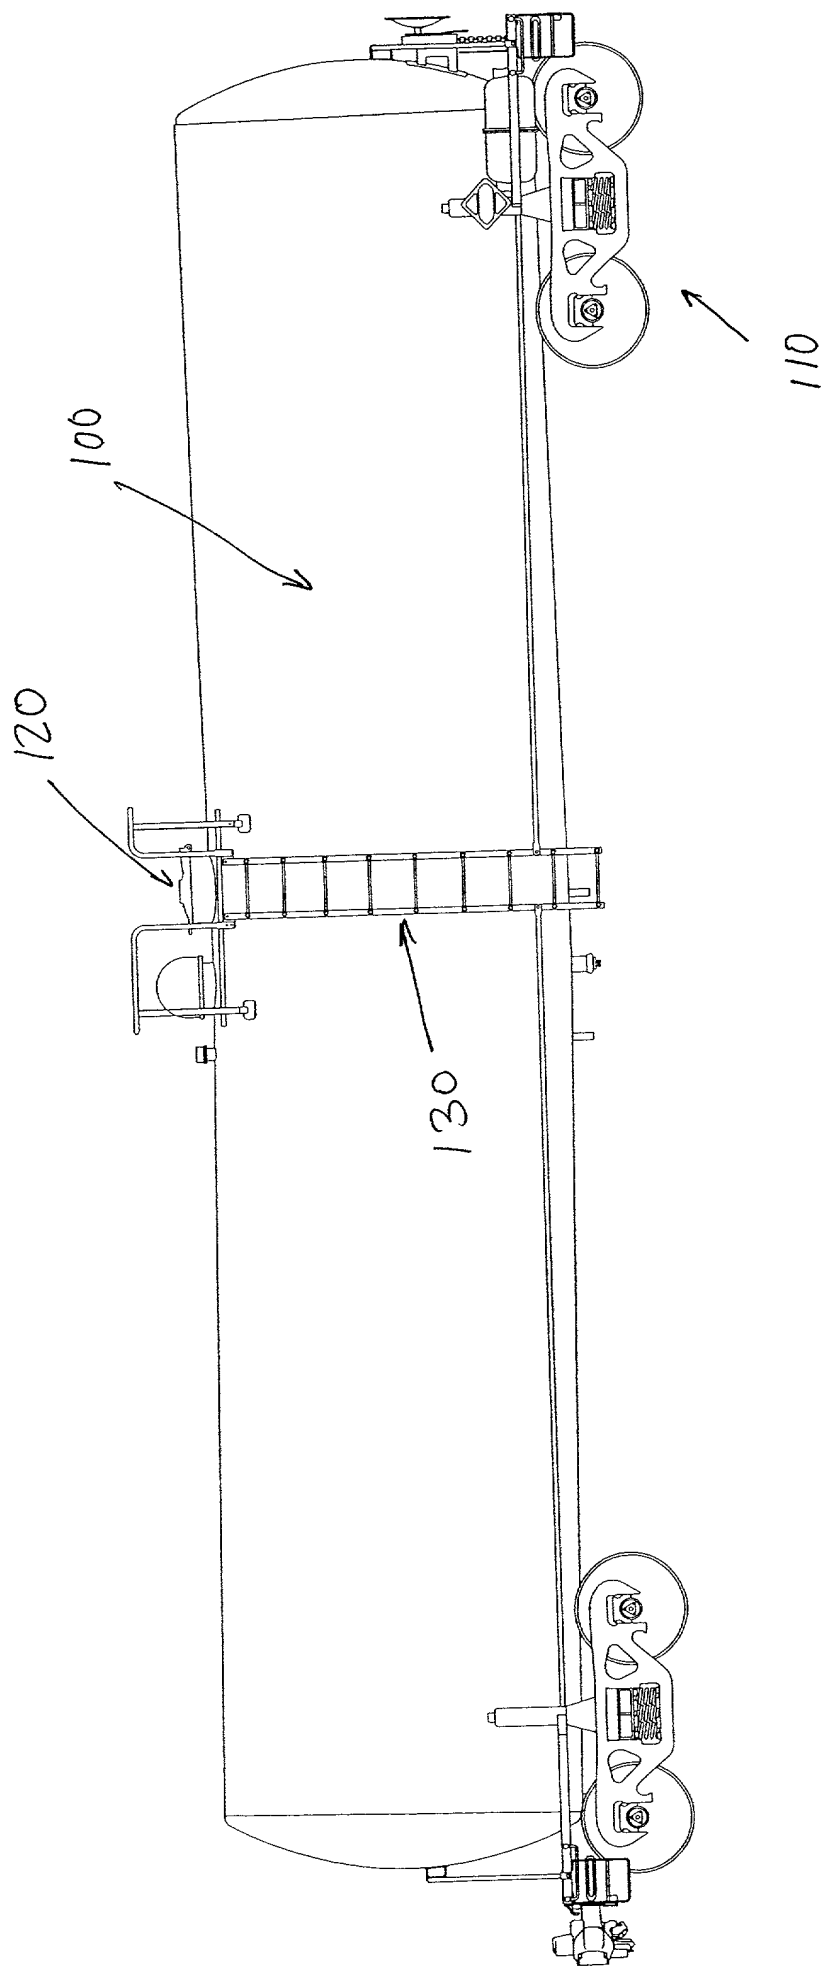
FIG. 1

5 Fig. 1 is a side view showing a typical tank car configuration;

Fig. 1 depicts a typical tank car which is subjected to examination and requalification according to the present invention. As shown, this vehicle is used to transport commodities and possesses a tank structure 100 with wheeled carriages 110
20 connected to the underside. It should be noted that, independent of the type of tank car which is involved, the tank per se is invariably a self-contained structure sufficiently rigid/strong to support not only its own weight but the weight of the cargo which is introduced into the tank. The understructure includes two or more wheeled carriage members or bogies 110 secured to the tank, such as by connectors or by the weight of the

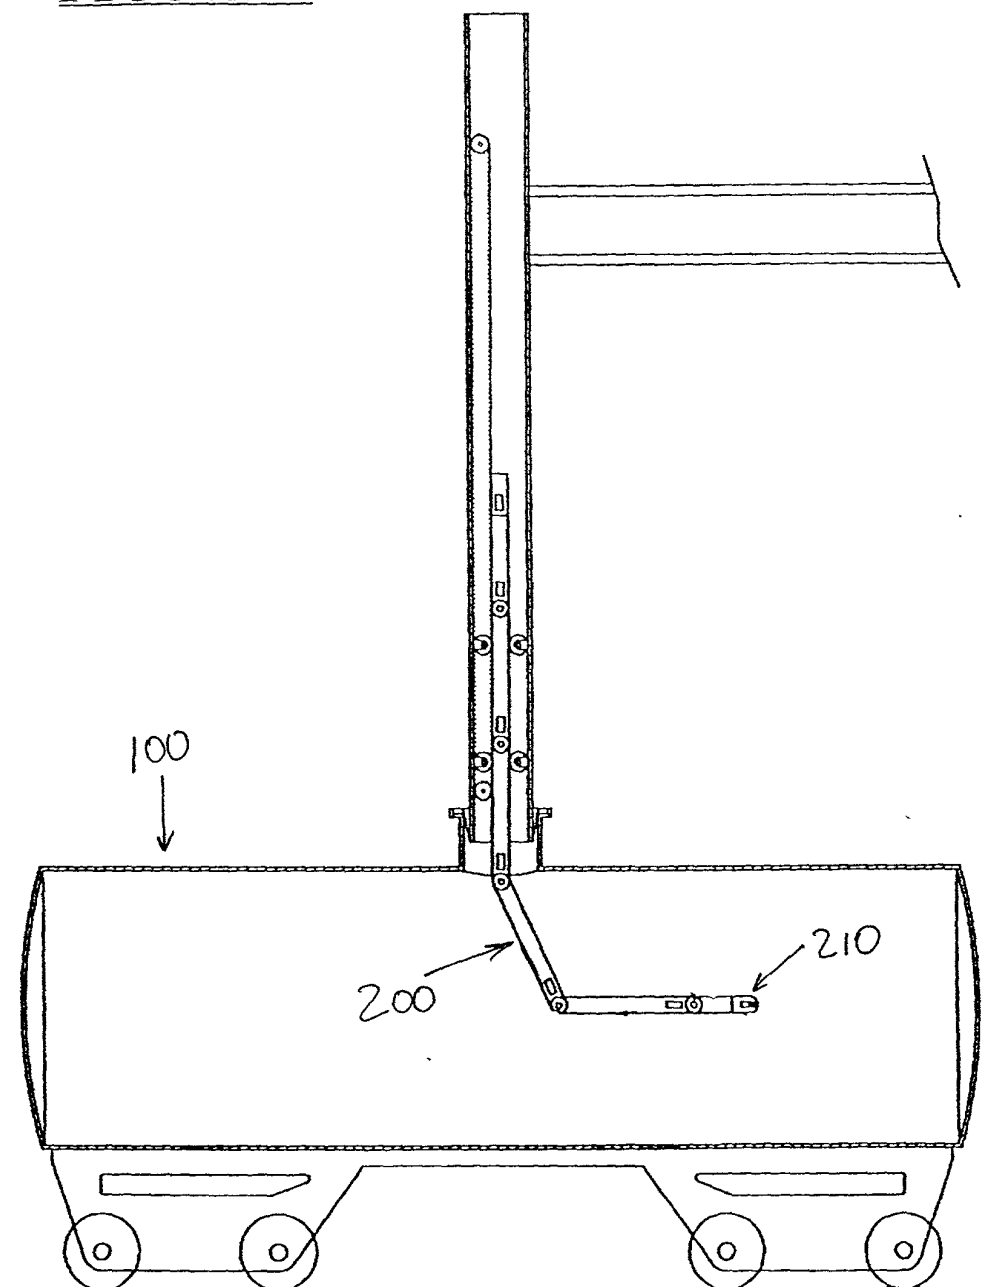
FIGURE 2

Fig. 2 is a schematic representation of a tank car which is being inspected robotically using an arrangement which could be used with the present invention in order to assist in inspecting/measuring the interior of a cylindrical vessel which forms a vital part of the tank car structure;

Fig. 2 depicts a tank car being inspected robotically via an arrangement provided in U.S. Patent No. 5,956,077 issued on September 21, 1999 to Qureshi et al. As shown, the tip of the snake-like probe 200 is provided with a sensor 210. Sensor 210 can, for the purposes of the present invention, take the form of an ultrasonic sensor or any other form of non-destructive sensing arrangement. Alternatively and/or in addition to the sensor, the tip can be provided with a camera and powerful illumination means for facilitating tank interior inspection. This type of arrangement has merit in the instances that the tank has not been cleaned out to the degree that it is safe for a person or persons to physically enter the tank and perform the required inspections, tests and data recordation. Non-limiting examples of sensor types and configurations compatible with the present invention are provided in United States Patent No. 5,256,966 issued on October 26, 1993; United States Patent No. 5,036,707 issued on August 6, 1991 to Paciej et al.; United States Patent No. 4,368,644 issued on January 18, 1983 to Wentzell et al.; United States Patent No. 4,658,649 issued on April 21, 1987; United States Patent No. 5,648,619 issued to Gustafsson et al. on July 15, 1997; United States Patent No. 4,490,833 issued to Inomata et al. on December 25, 1984; or United States Patent No. 5,619,423 issued on April 8, 1997 to Scrantz.

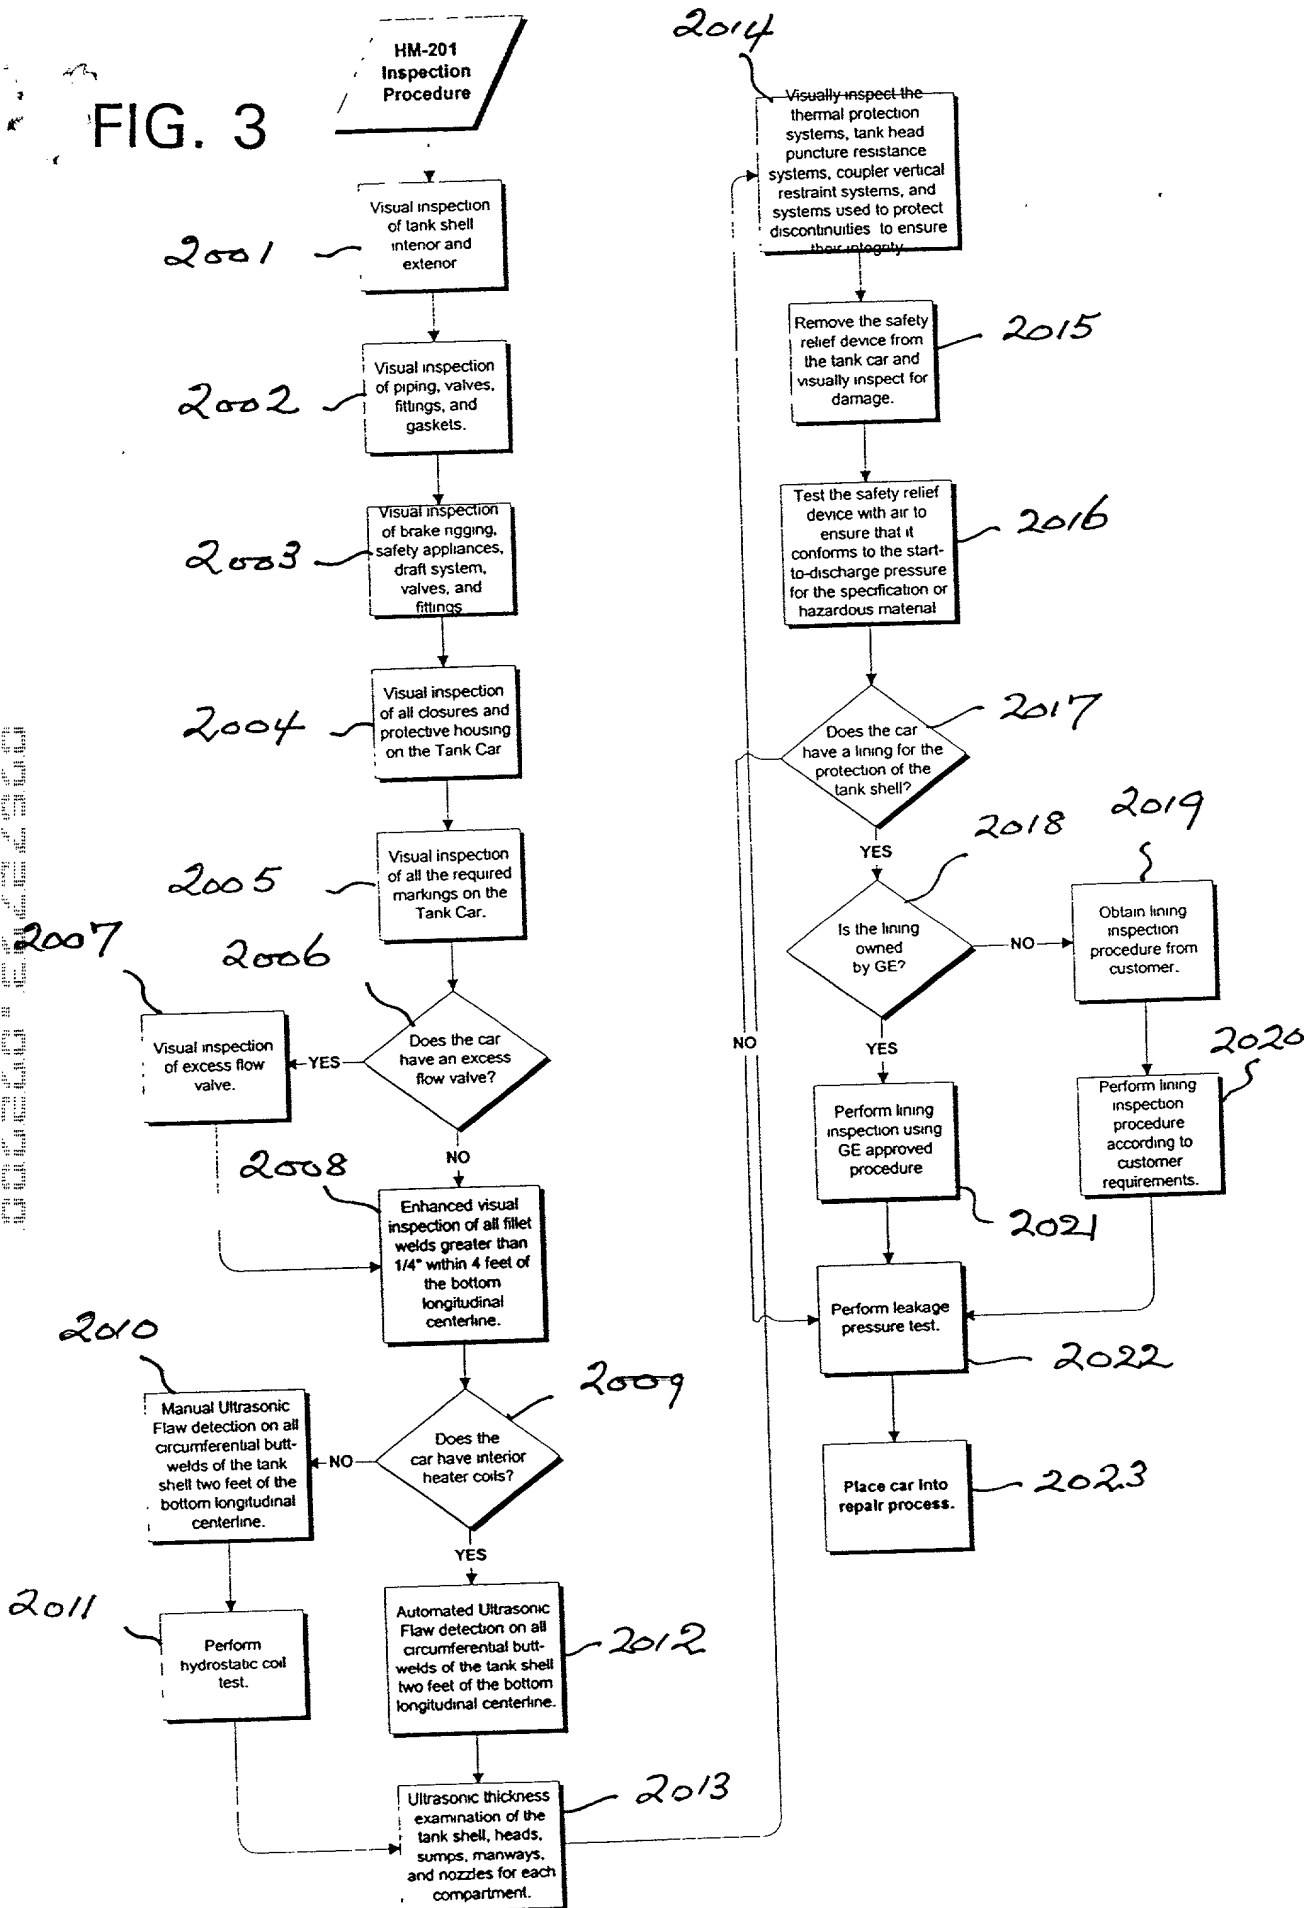
FIG. 3

10 Fig. 3 is a flow chart depicting the general procedure in accord with the present invention;

Test. The flow chart in Fig. 3 depicts the general flow of the process in accord with the invention.

Subsequent to this determination, ultrasonic flaw detection on all circumferential butt-welds of the tank shell which are two feet from the bottom of the longitudinal center line of the car, is carried out in steps 2010 or 2012. As depicted in the flowchart of Figure 3, manual ultrasonic welding is performed in the event the car has interior heating coils and automatic ultrasonic welding is performed in the event the car does not have interior heating coils. Although not indicated, manual ultrasonic welding may also be performed when the tank car does not have interior heating coils. After ensuring of the ultrasonic tester in a manner known to those skilled in the art, the weld and surrounding areas are cleaned if necessary to remove, for example, residual commodity, weld splatter, rust scale, rust bloom, and surface pitting in excess of about 0.030", to permit accurate inspection of the circumferential butt-welds, shown in Figure 13A. It is preferred that, at a minimum, the circumferential butt-welds within approximately two feet of each side of the bottom longitudinal centerline are inspected using an ultrasonic flaw detecting device.

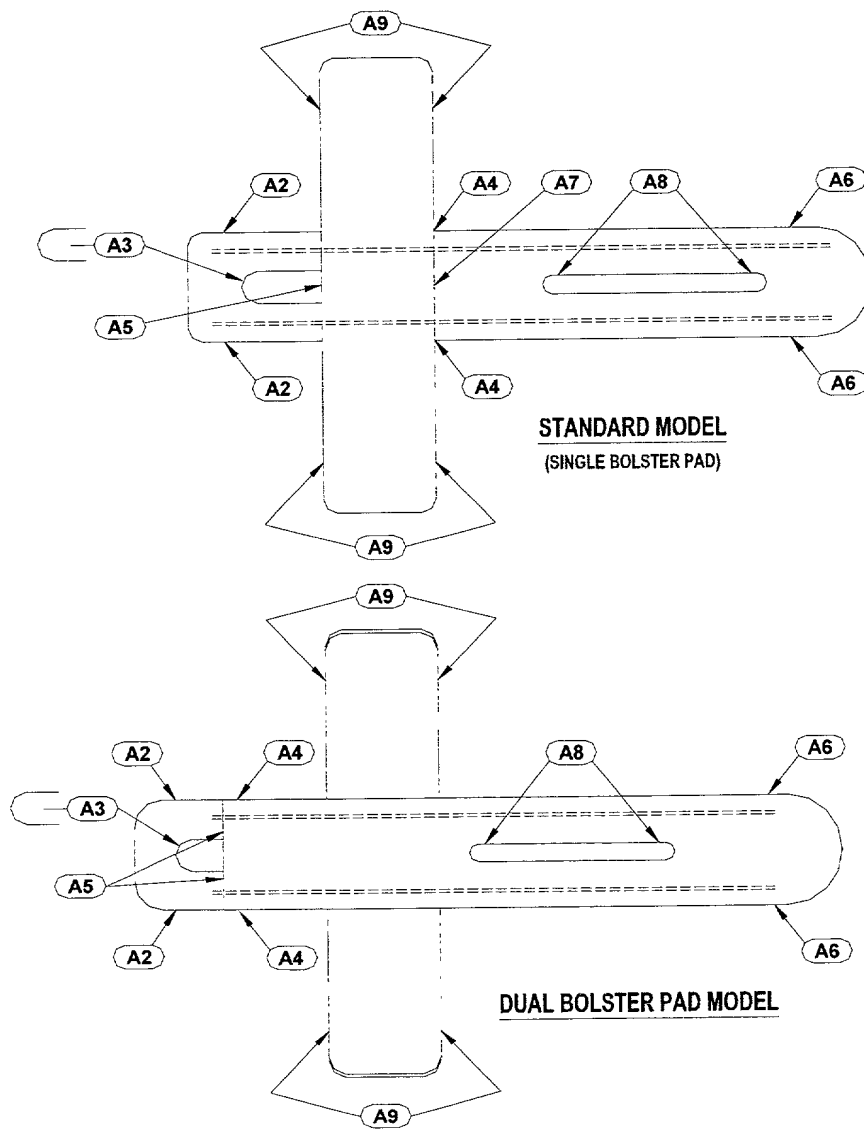
Figure 7A

20 Figs. 7A-7H depict an aspect of the enhanced inspection of tank car welds as they relate to Evans Railcar (EVA) and WBR (original EVA design modified to include head brace) stub sill configurations.

Figures 7A-7H depict another preferred aspect of the invention wherein the detailed weld inspection in accord with step 2008 particularly relates to welds on tank cars built using the Evans Railcar (EVA) and WBR (original EVA design modified to include head brace) stub sill configurations. In most respects, the weld locations, relation to

regulatory requirements, and inspection requirements are as set forth with respect to Figures 5A-5H, above, and the related discussion. Reference to Figures 7A-7H, which use the same reference numerals as Figures 5A-5H are illustrative of the differences between the tank car designs.

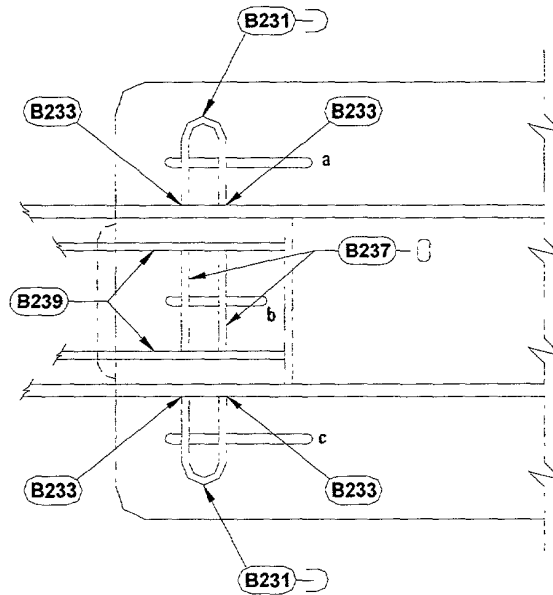
FIGURE 10H

NOTE: Outboard of bolster, wing bar not shown for clarity.

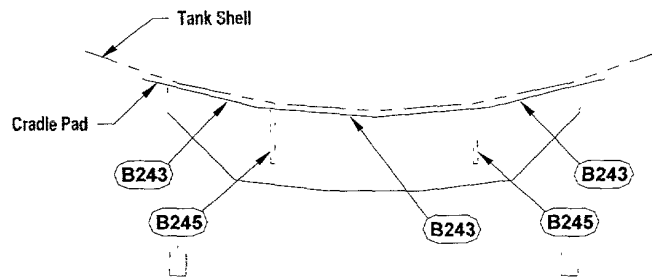
NOTE: Inboard of bolster at end of cradle pad, looking outboard.

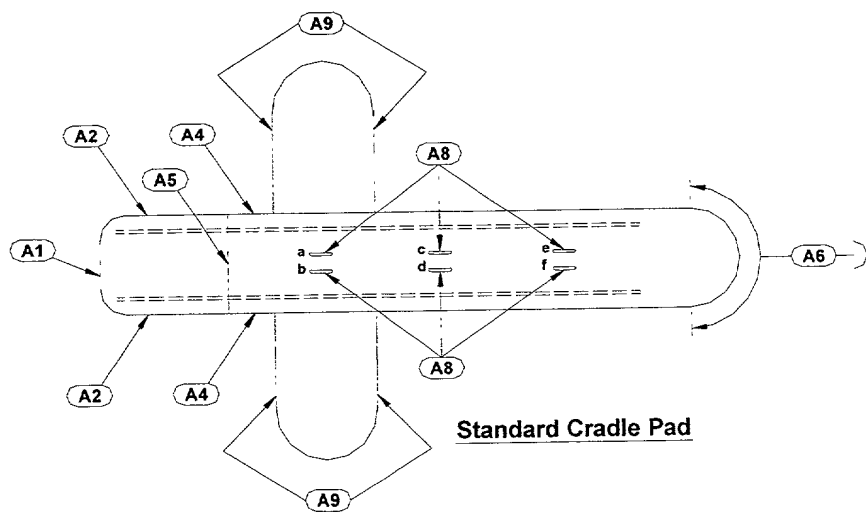
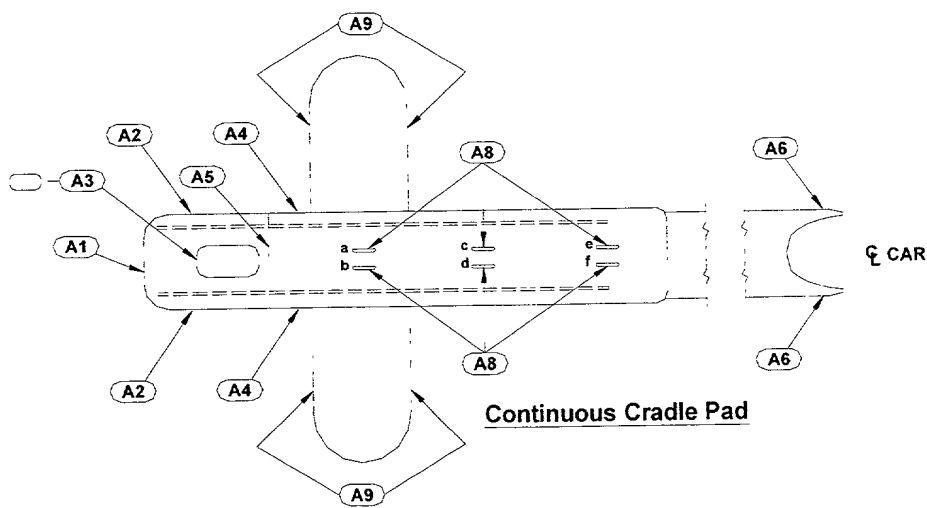
FIGURE 12A

Figures 12A-12H depict yet another preferred aspect of the invention wherein the detailed weld inspection in accord with step 2008 particularly relates to welds on ZBN stub sill designed tank cars, primarily manufactured by Union Tank Car Company (UTC).

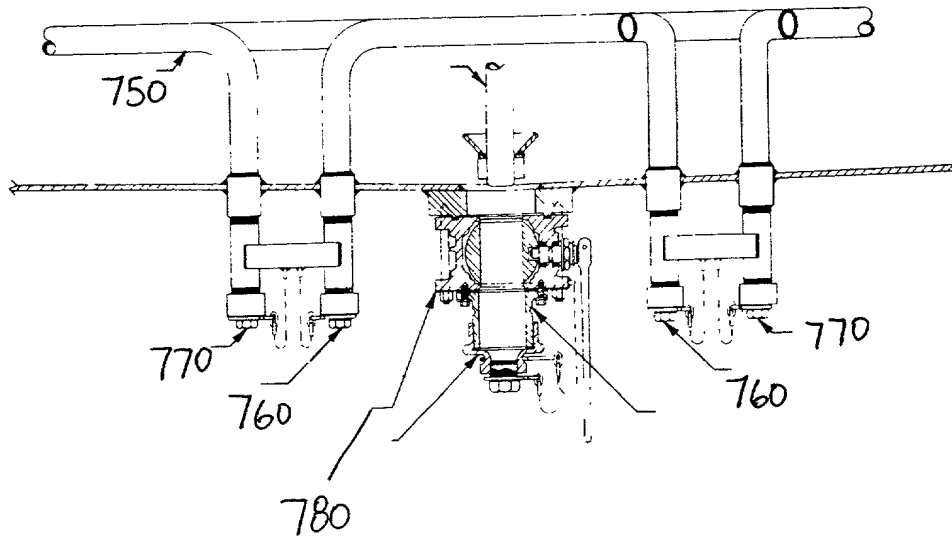
FIGURE 13B

15 Fig. 13B illustrates a typical coil leg arrangement.

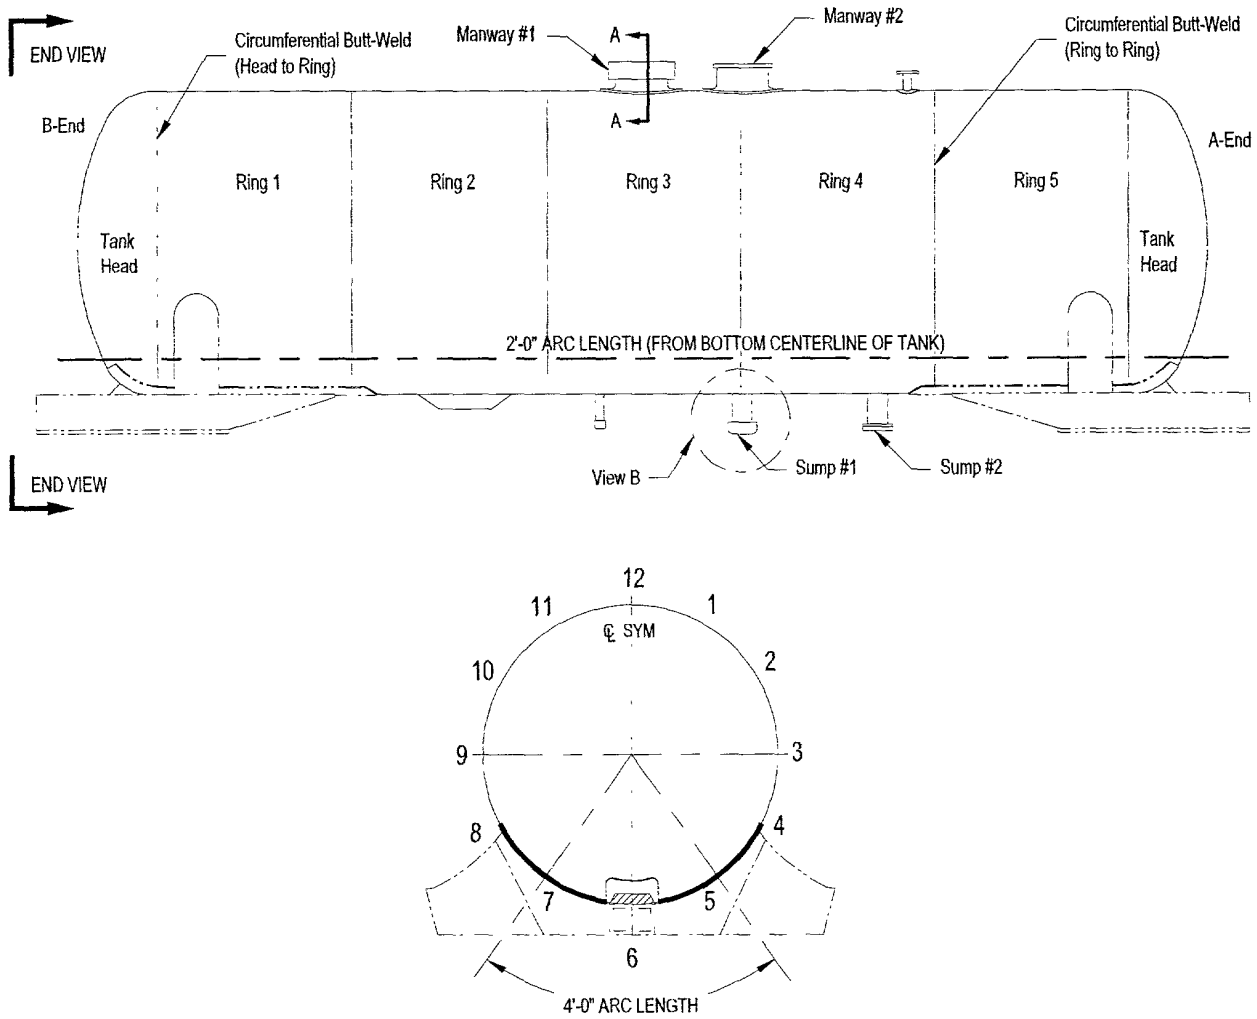
FIGURE 14A

higher numbers as designators, such as opening #2, as shown in Figure 14A. All openings are divided into 2 hemispheres transverse to the horizontal centerline of the tank; the half circle closest to the A-end and the half circle closest to the B-end as shown in Figure 14A, sectional view A-A. The damage can then be characterized relative to the axial distance
5 from the center of the damaged area to the inside of the shell

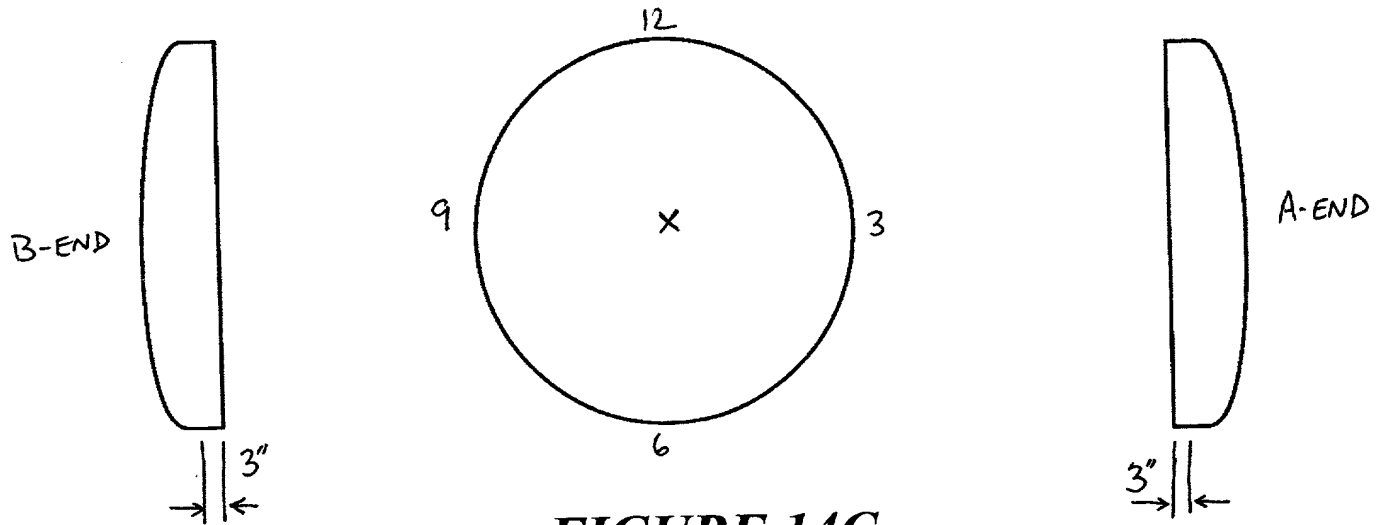
FIGURE 14B

The service life shell thickness test, itself, should start at the B-end head. Four readings should be taken approximately 3 inches from the circumferential weld. The readings should be taken at 12 o'clock, 3 o'clock, 6 o'clock and 9 o'clock as shown in Figure 14B, and one measurement should be taken in the center of the head. The same
10 pattern should be used for the A-end head. For each of the rings, as shown in Figure 14A, it is preferred to obtain 4 readings approximately 3 inches from each of the circumferential welds bounding the ring at the 12 o'clock, 3 o'clock, 6 o'clock and 9 o'clock positions. Thus, each ring will have 8 readings. Stated another way, circumferential welds disposed between adjacent rings have 4 readings taken on one side of the weld (i.e., displaced 3"
15 toward the B-end) and 4 readings taken on another side (i.e., displaced 3" toward the A-end), as shown in Figure 14C. Shell thickness readings of local openings should be taken at two readings on the horizontal centerline of each service equipment opening. The first reading should be on the B-end within 3" of the inside shell diameter wherein, as noted previously, openings are divided into 2 hemispheres perpendicular to the horizontal

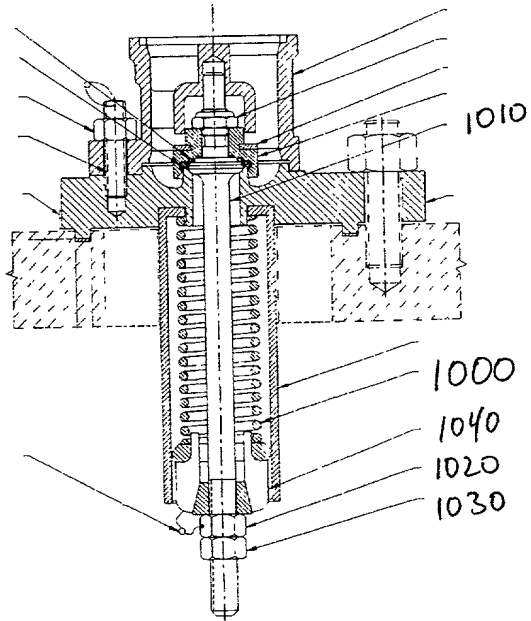
TYPICAL INTERNAL STYLE SAFETY RELIEF VALVE

Midland A-1075-JVP Design

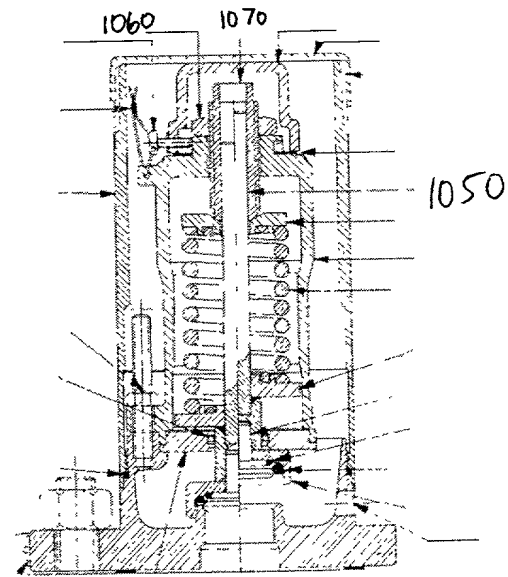
FIGURE 15C

TYPICAL TOP MOUNTED SAFETY RELIEF VALVE

Midland A-1435 Design

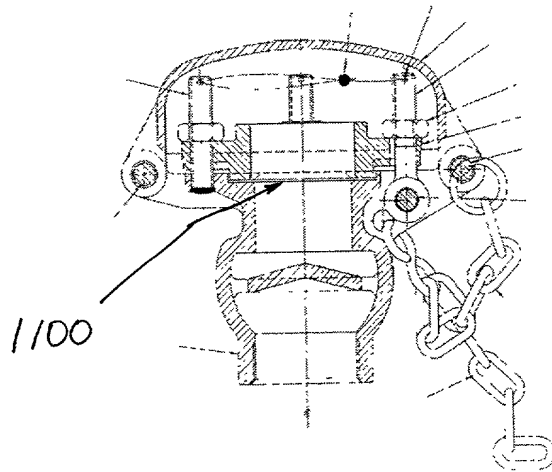
FIGURE 15D

TYPICAL SAFETY VENT

Midland A-424 Design

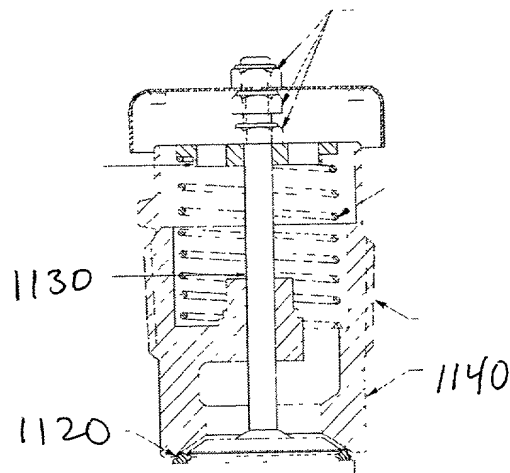
FIGURE 15E

VACUUM RELIEF VALVE

Midland A-208-W-10 Design

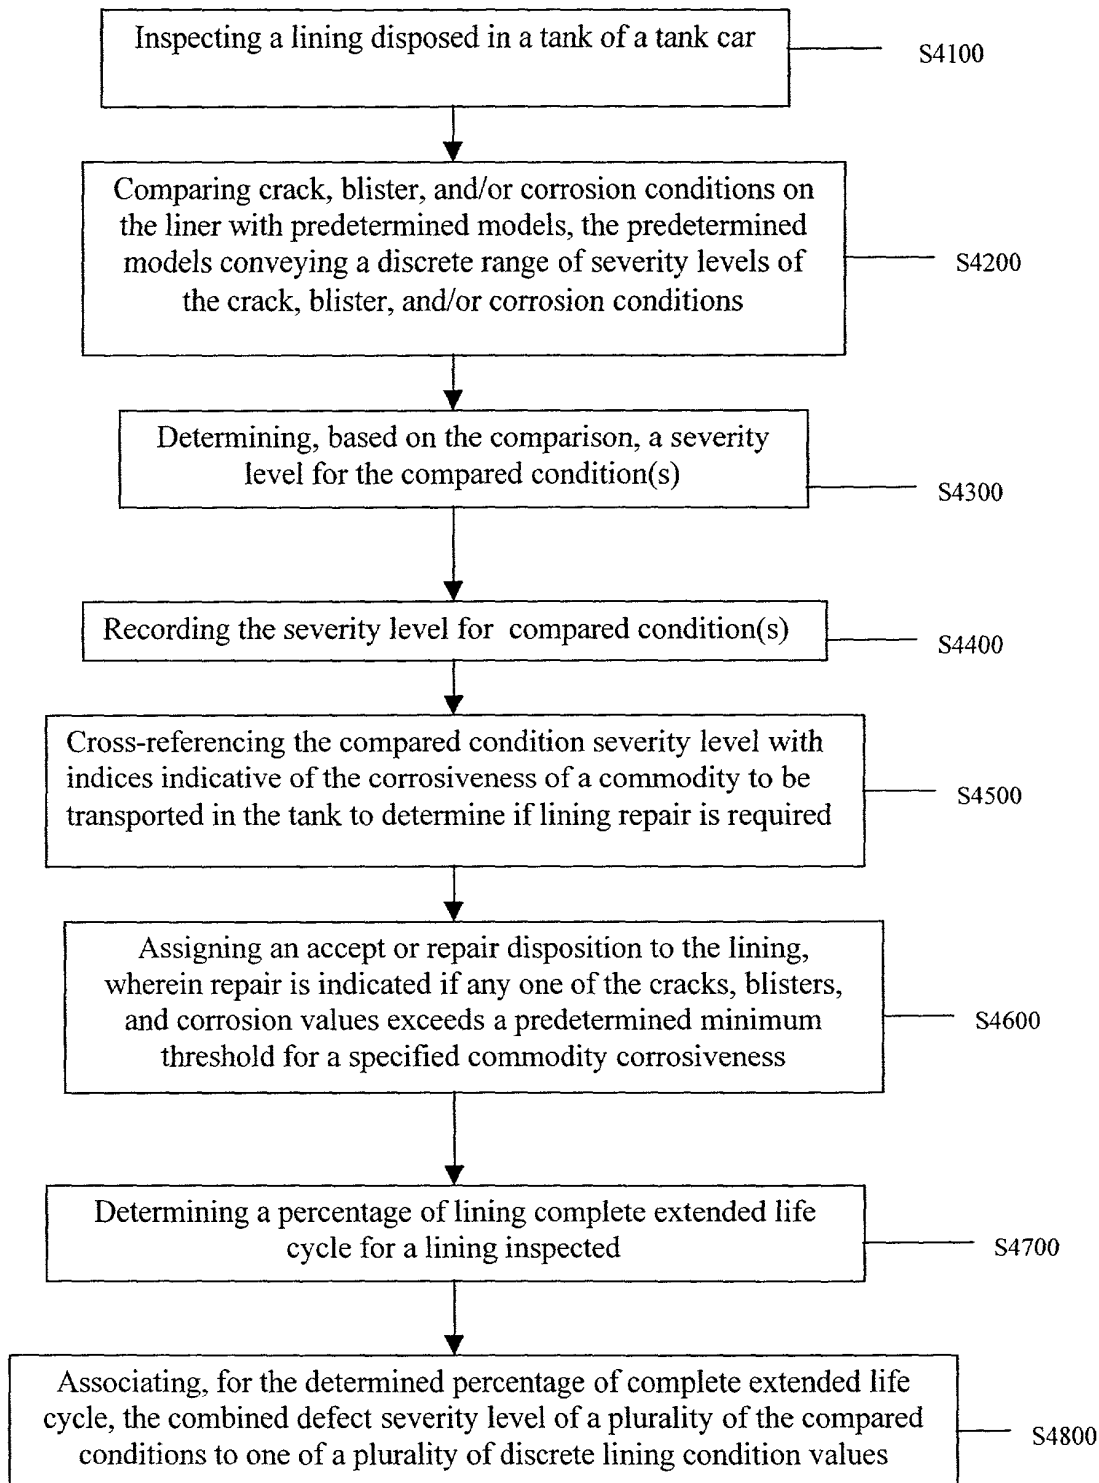
Figure 17

The test procedure for inspecting a vehicle adapted to transport commodities in accord with the invention is depicted in FIG. 17. In step 4100, the tank car lining is inspected. Step 4100 may include inspection for staining or discoloration of the lining or coated surface. All surfaces are visually inspected for signs of contrast in color. If such discoloration is observed, the inspector must use a cleaning solution such as a solution of 1% hydrochloric acid diluted in water in combination with a light colored, preferably white, cloth to determine whether or not the cloth is itself discolored by the stain.

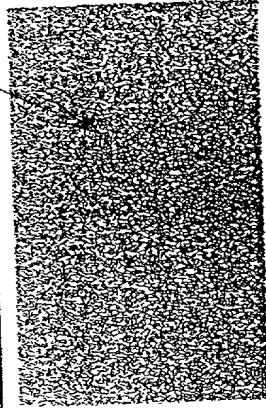
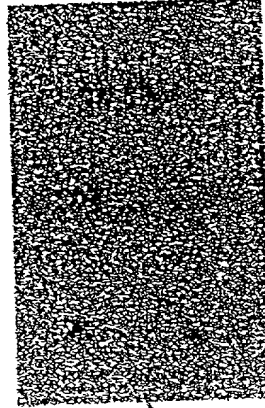
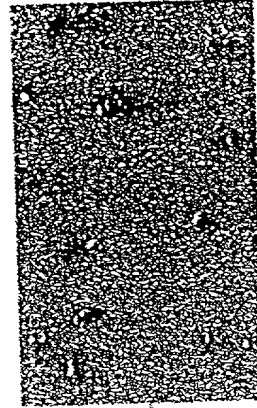
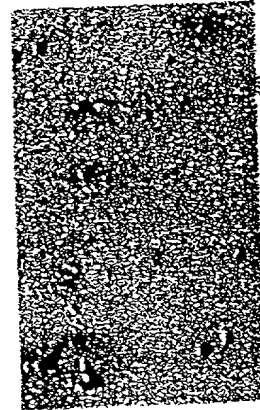
Re 1 - smallest corrosion easily seen by eye

Re 2 - small amounts of corrosion

Re 3 - Medium amounts of corrosion

Re 4 - large amounts of corrosion

Scattered

Localized

Visually compare the surface with the photographic reference standards to determine the scale of degree of rusting.

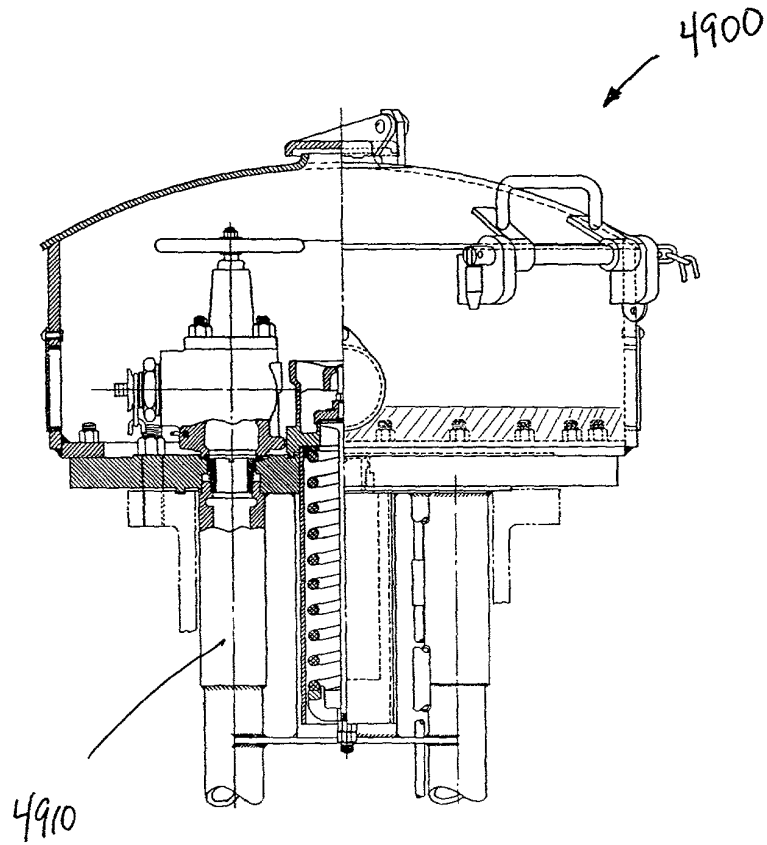
Figure 23

Fig. 23 depicts a typical protective housing arrangement.
10

If no bubbles are seen then the pressure plate to nozzle joint is tested. A circular
20 piece of 1/16", 1/8" or 3/16" closed-cell backing strip, gasket material, or appropriate caulking material approximately 103" in length for the 18" manway nozzle and approximately 109 1/2" in length for the 20" manway nozzle is applied to the joint. This should create an open area approximately 1/4" by 1/8". Ensure the gasket is tight in the joint and sealed all around the joint, as shown in Figure 23. Alternatively, a circular gasket

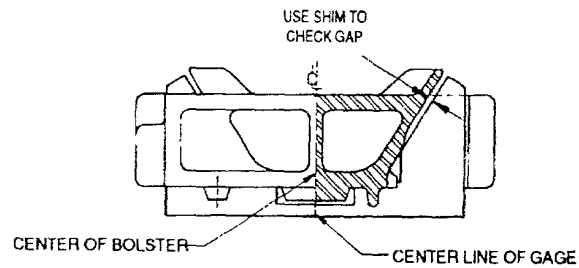
GAGE IN WORN BOLSTER POCKET

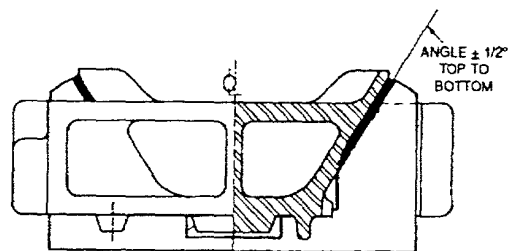
GAGE IN REPAIRED BOLSTER POCKET

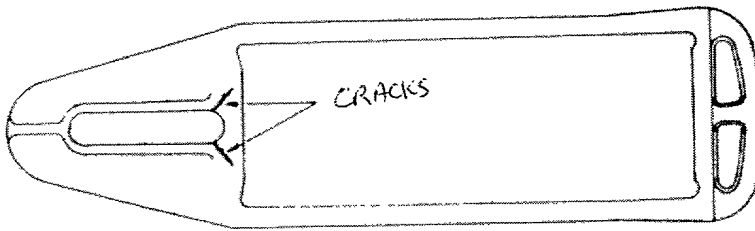
Y40, SY40, OR YS93 DESIGN YOKES

FOR USE WITH TYPE E COUPLER

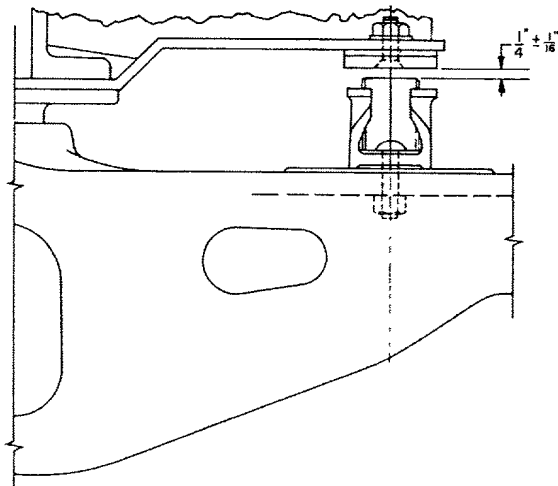
Figure 26a

Figs. 26a-b illustrate a body center plate and side bearing visual inspection
method.

Further in accord with Rule 88.B.2, the body center plate and side bearings are inspected. For roller side bearings, illustrated in Figure 26a, the side bearing clearance must be measured prior to removing the trucks from the car. A step gage or other suitable gage or instrument is used to measure the gap between the top of the roller and the side bearing. The gap should be between $3/16$ " and $5/16$ " as shown in Figure 26a. It is acceptable to average two side bearings diagonally at each end of the car. For constant contact models, as shown in Figure 26b, the trucks must first be removed and then the rockers removed from the side bearing cage. The height between the bottom of the roller cage and the side bearing is then measured and it should be between 5" and $5\frac{1}{8}$ ", as shown in Figure 26b. It is acceptable to average two side bearings diagonally at each end of the car. Following the above measurements, the trucks and rockers, as applicable, are replaced. The side bearings are visually inspected for cracked, broken, or missing portions and for worn or bent portions exceeding $1/8$ ". The side bearings are checked to ensure they are the correct side bearing for the particular car and the side body bearing is inspected for wear to determine if the minimum thickness at the centerline of the fastener is below the minimum acceptable limit of $5/8$ " (or $3/8$ " for cars built prior to 1981 with flat bearings).
